9/1/2021

Justin Reilly
Colliers International
2267 Gundersen Dr.
San Jose, CA 95125
(408) 482-1033
justin.reilly@colliers.com

Re: Tree protection for New Single-Family Home at 16484 South Kennedy Road, Los Gatos, CA, 95030, Parcel 1

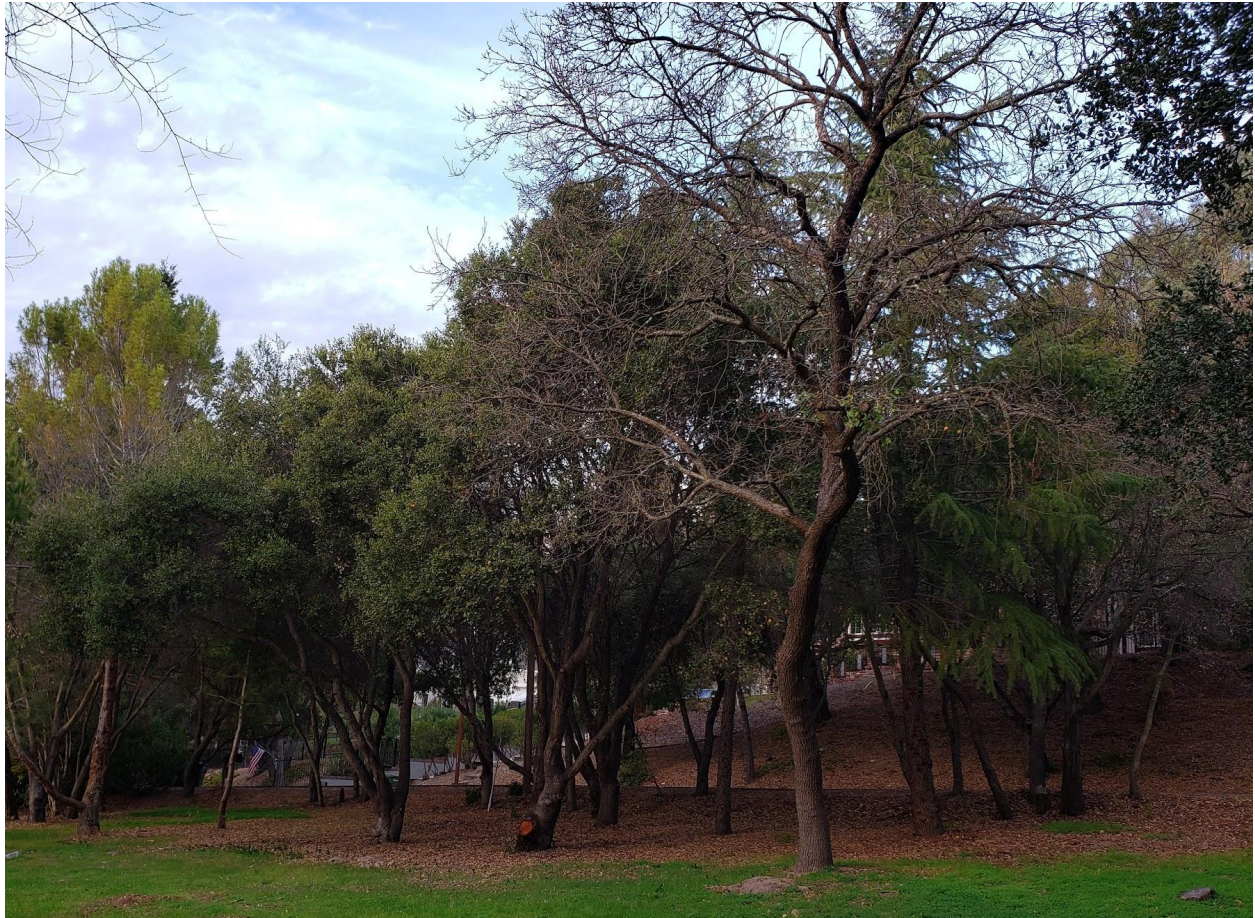
Image 1: mixed species grove #1-31 (background, right to left), deodar cedar #7 (background, right), and valley oak #8 (foreground, right)

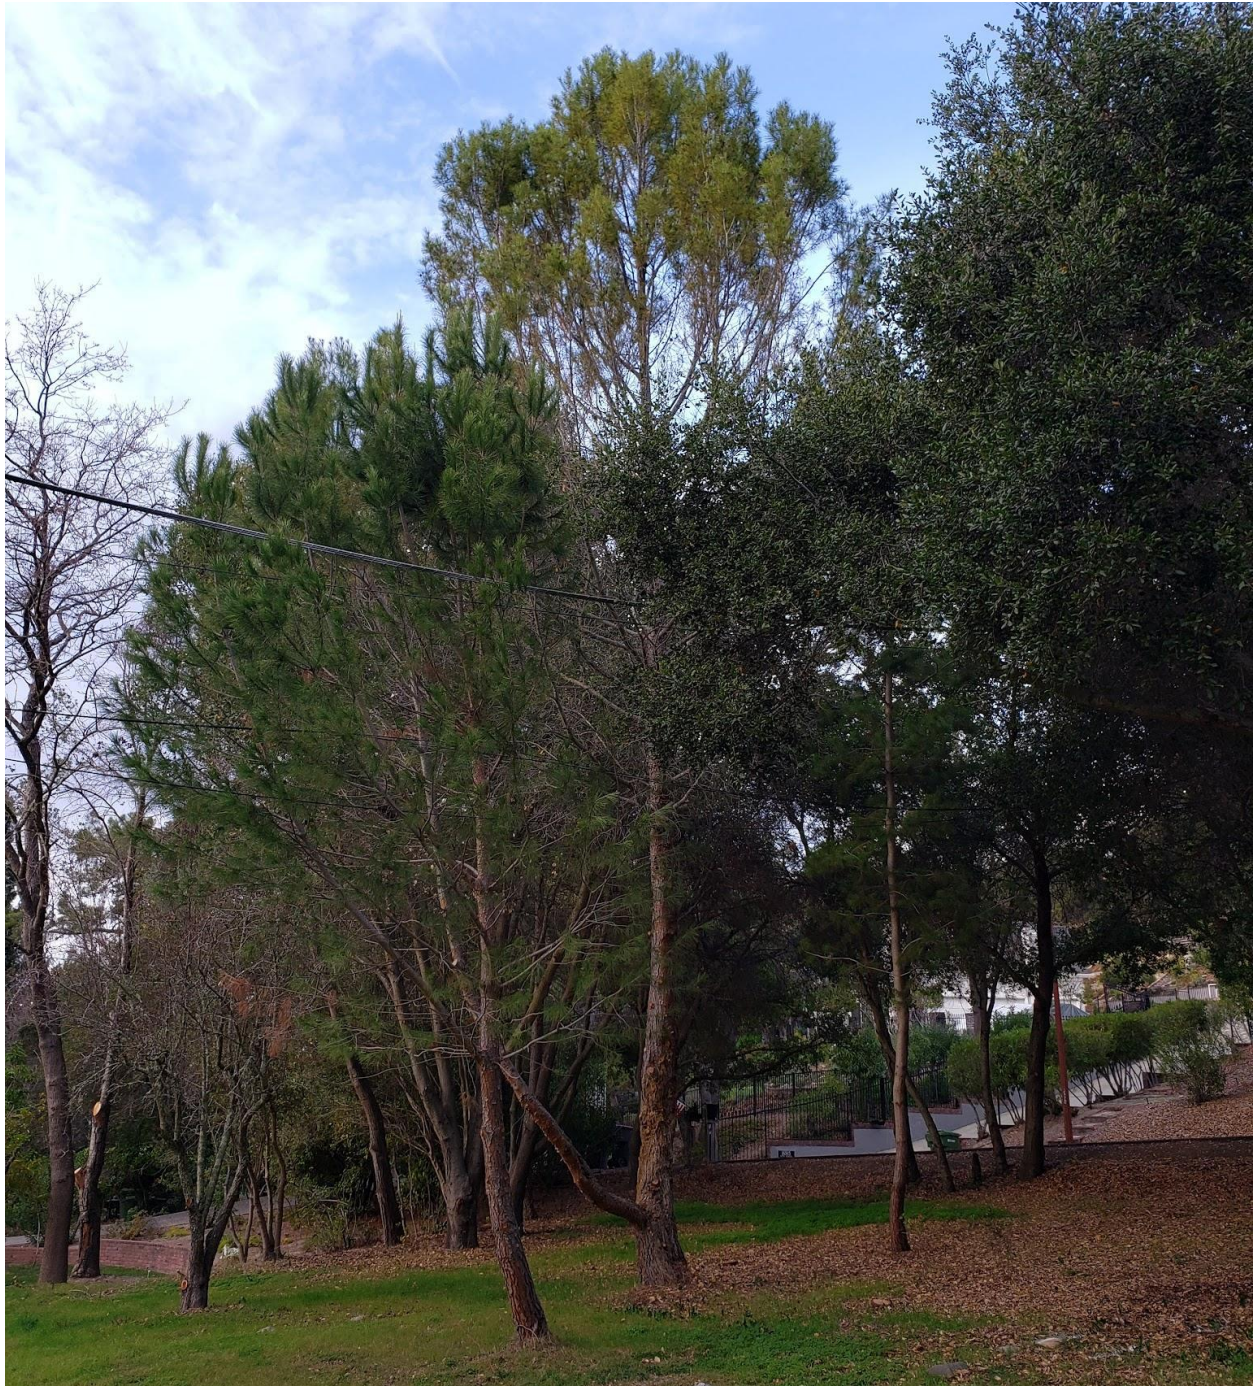
Image 2: Italian stone pines #32-34 (right to left, #32 obscured)

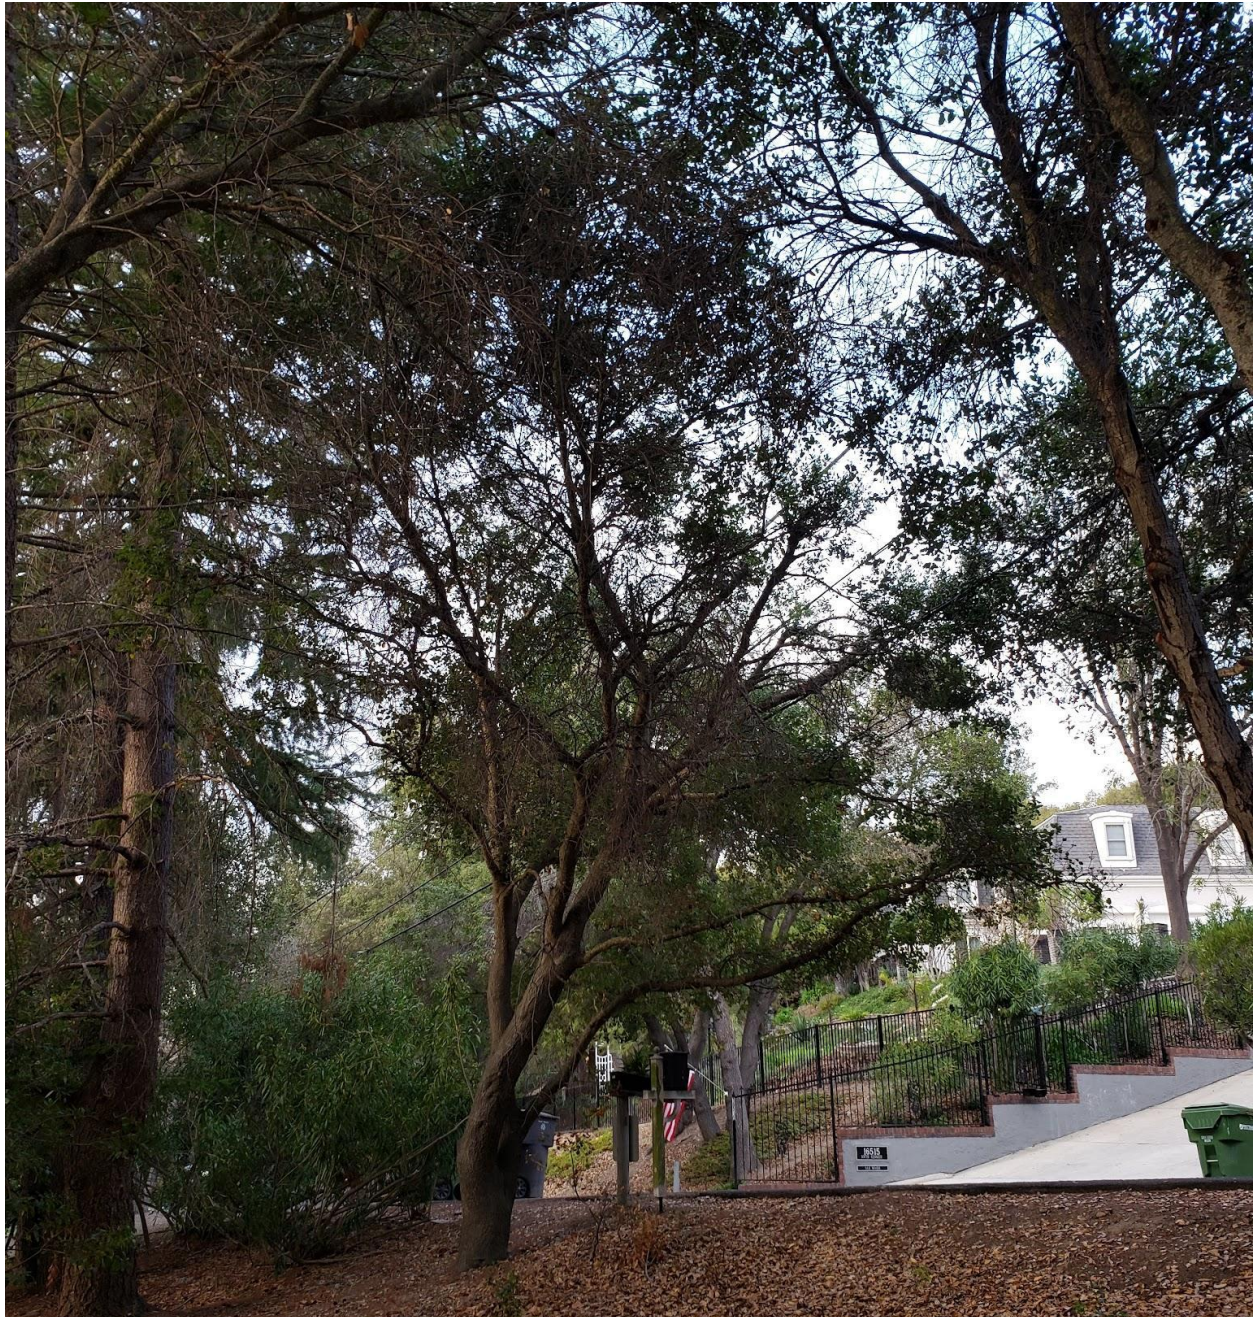
Installation of the proposed driveway and associated grading and retaining walls will likely cause major impacts to trees #21 and 22; moderate impacts to tree #29; and minor impacts to tree #25.

Image 3: coast live oak #25

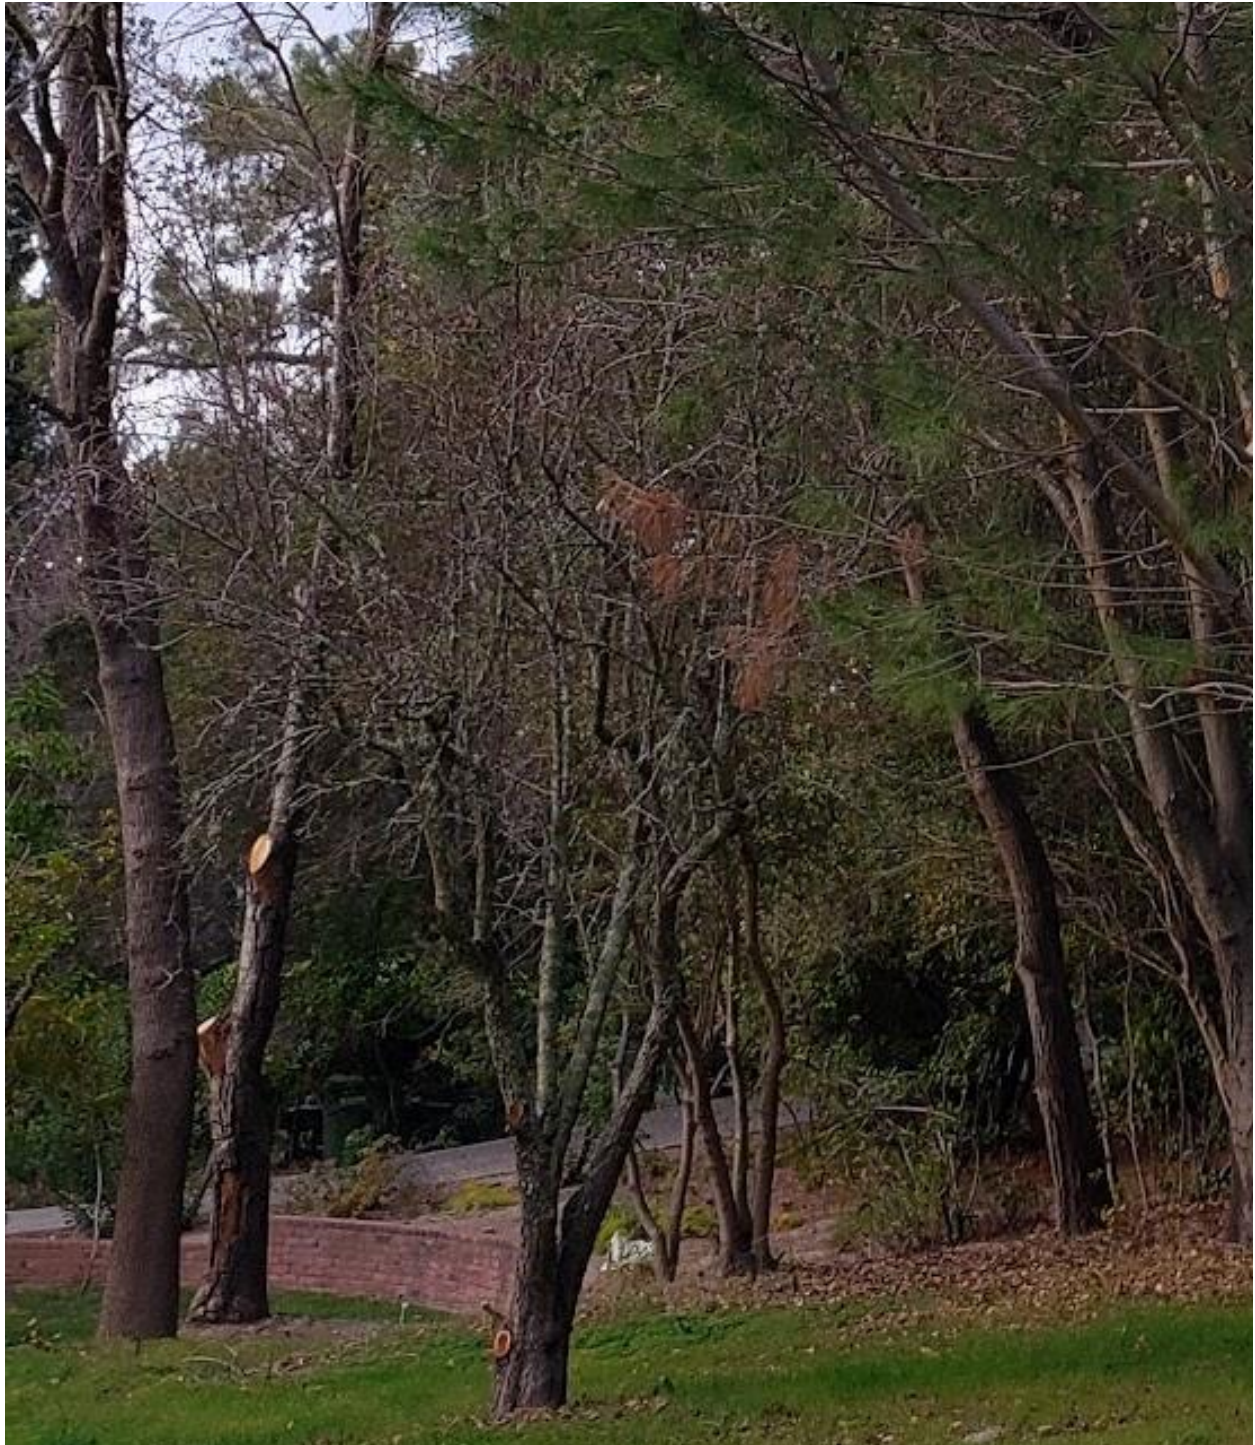
Trees #24, 30, 33, 35, 38, and 40 must all be removed for the proposed driveway.

Image 4: plum #35

1. Remove trees #24, 30, 33, 35, and 37-42, upon receipt of a permit from the Town of Los Gatos.

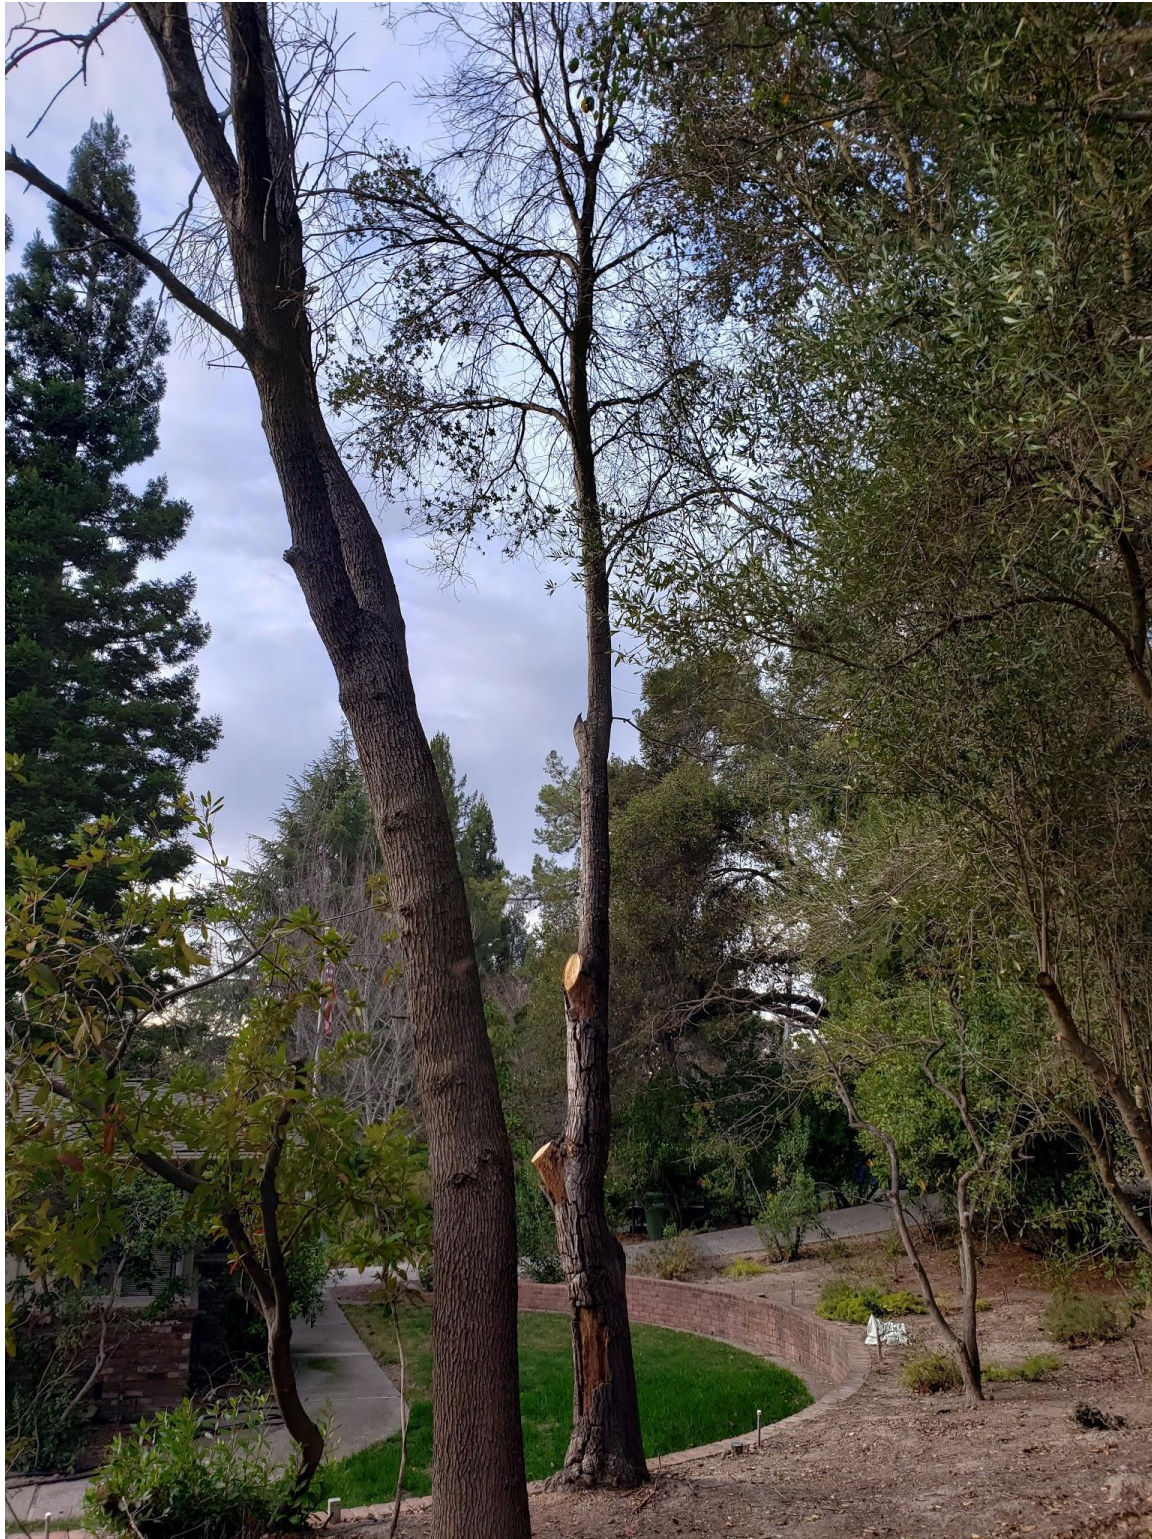
Tree #36 - this tree is effectively dead, so impacts are irrelevant. Its trunk and immediate root zone are not affected by any proposed project features.

Trees #37 and 39 - these trees' trunks lie within the footprint of the proposed parking area.

Trees #37 and 39 must be removed for the parking area to be installed.

Tree #36 is effectively dead, so impacts from the project are irrelevant. Tree stability will likely be unaffected by project features.

Image 5: coast live oak #36 (center, background, bark delaminating) and trunk of valley oak #37 (left, foreground)

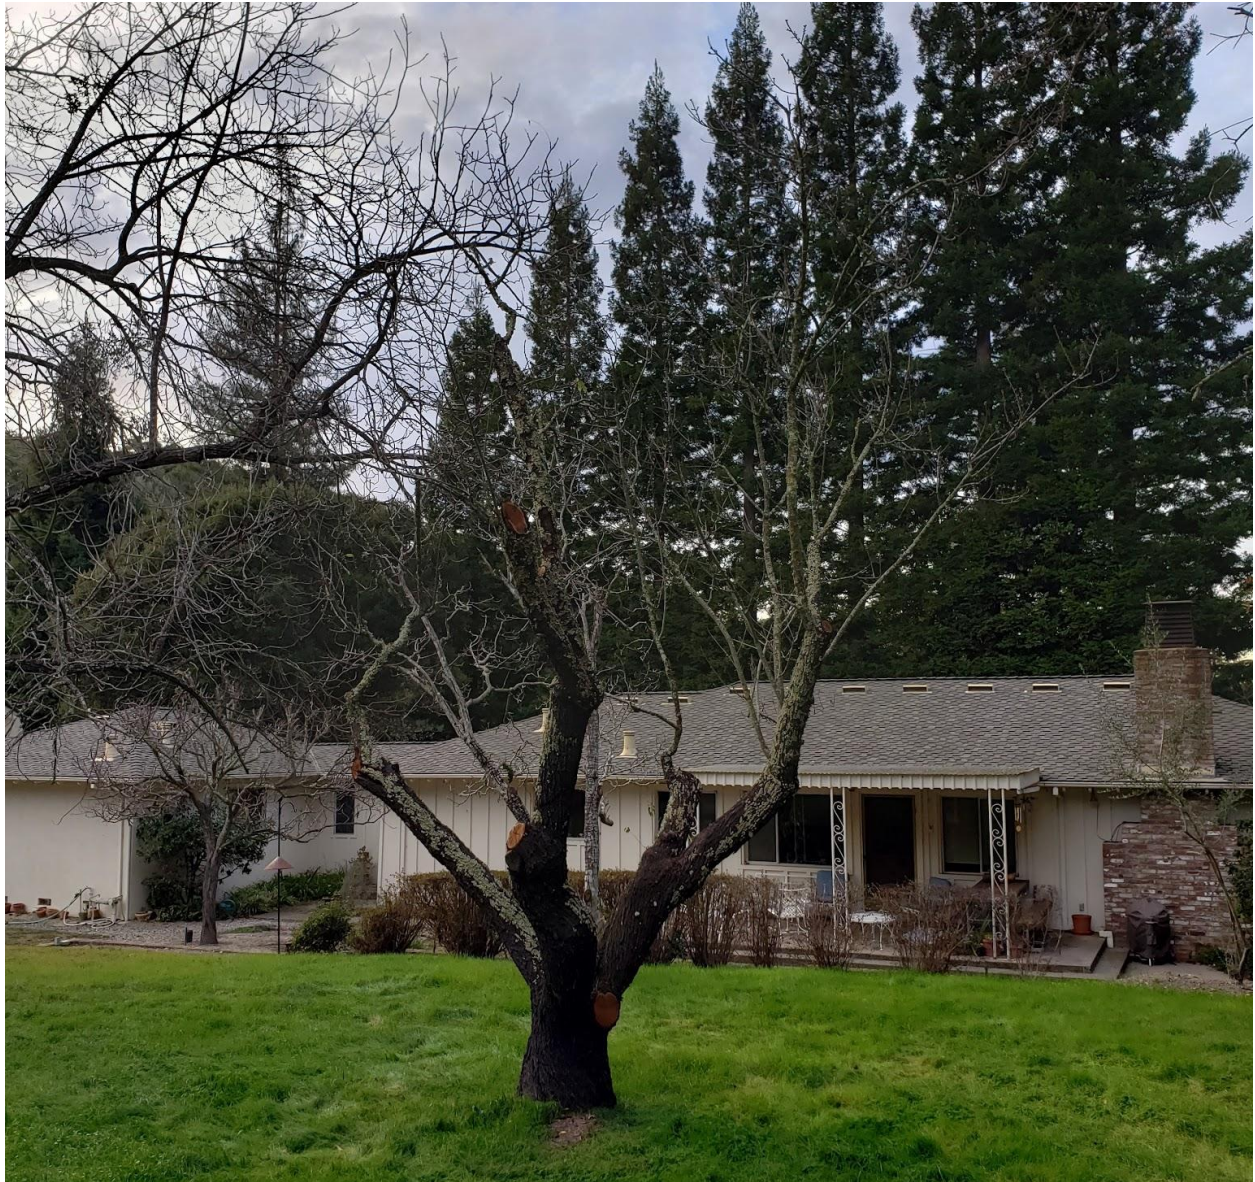
Image 6: almond #38

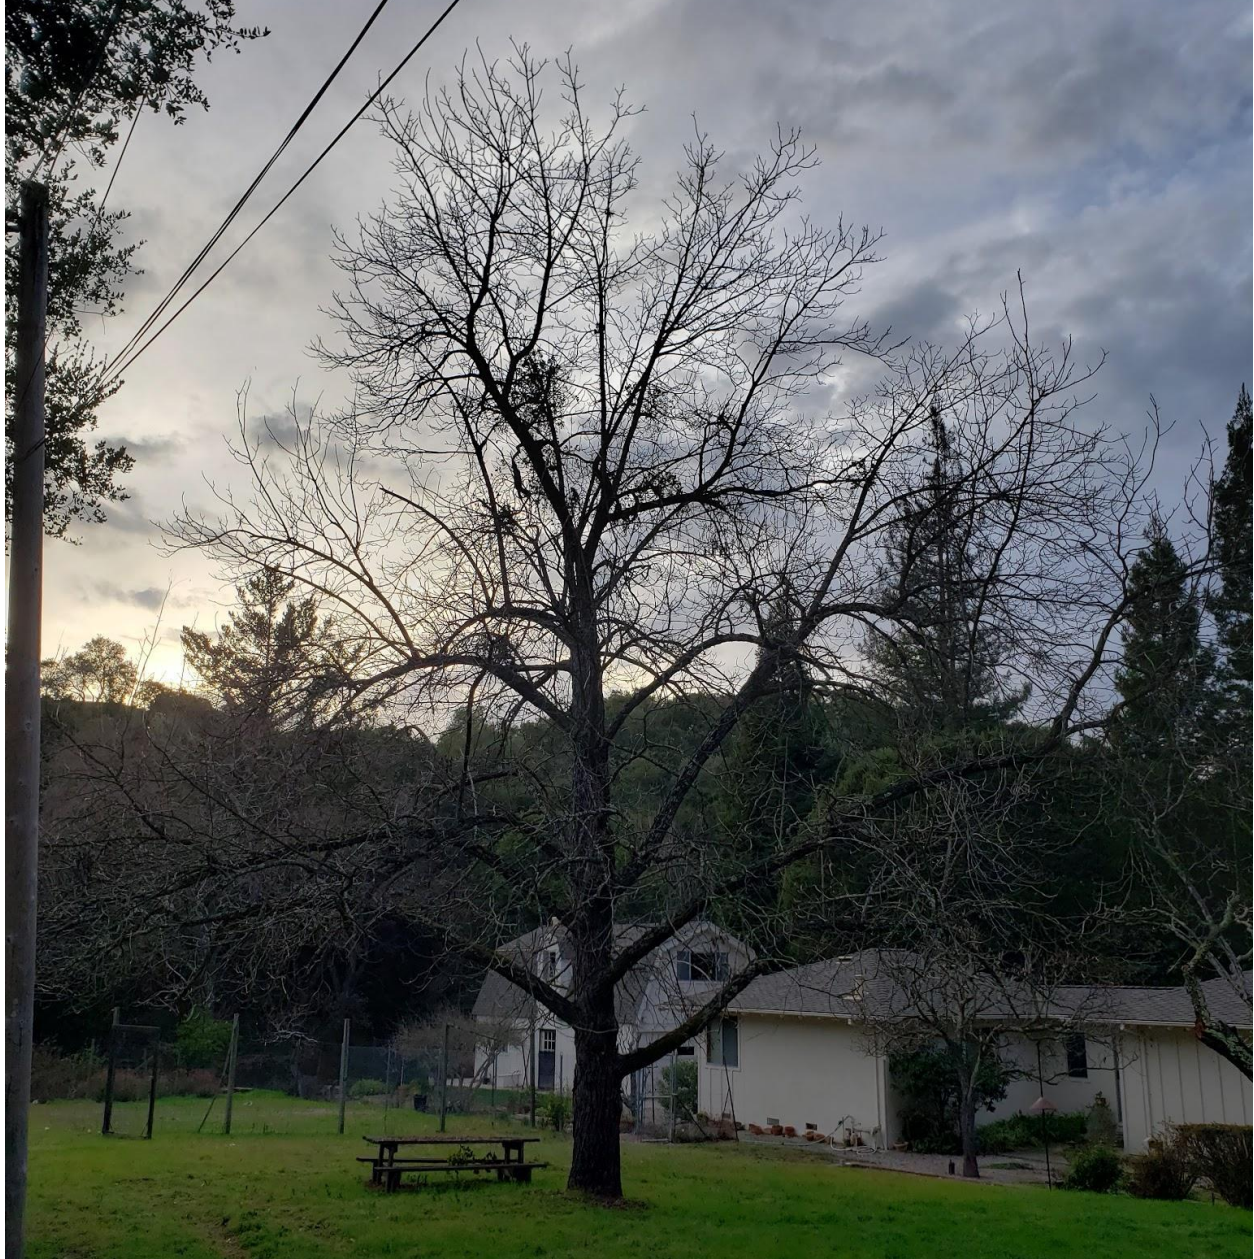
Tree #40 - this tree's trunk lies within the proposed house footprint.

Tree #40 must be removed for the house to be constructed.

Image 7: Northern California black walnut #40

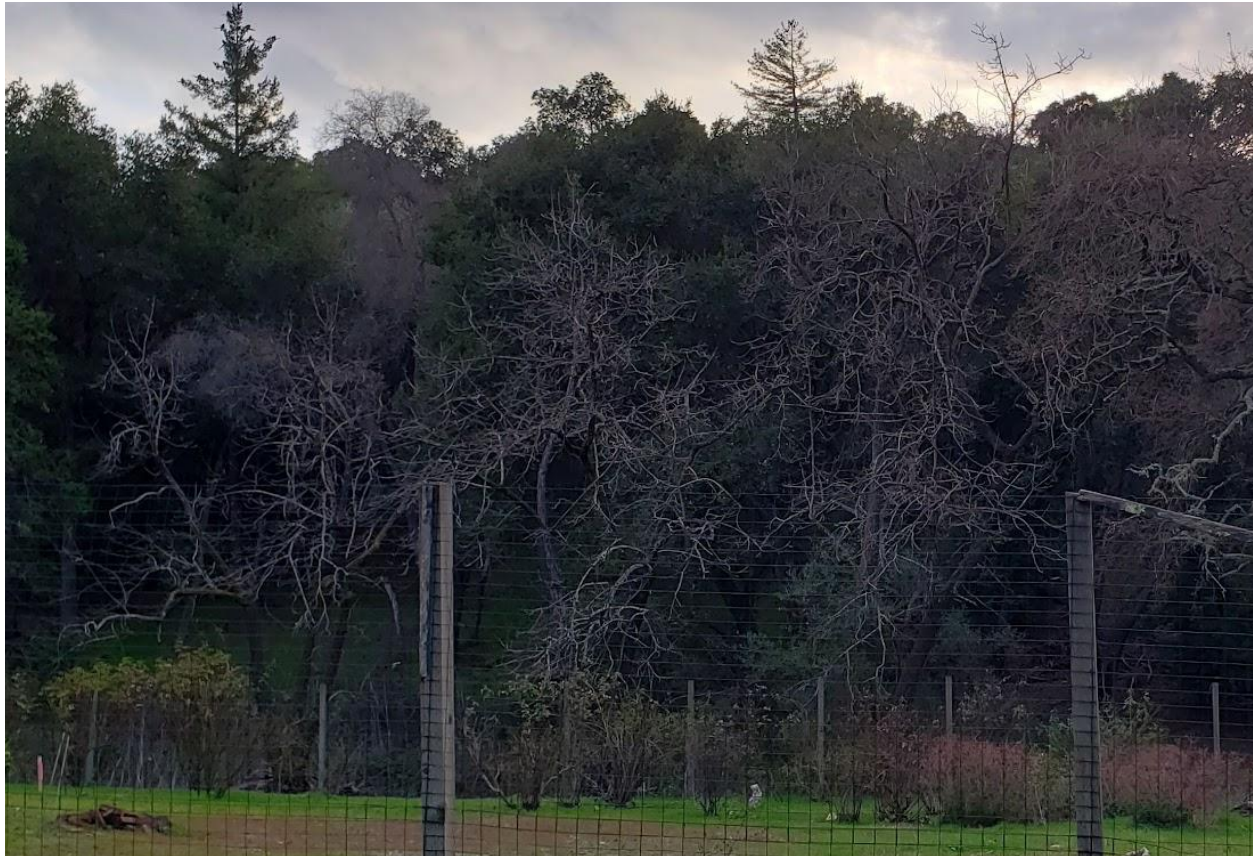
Trees #41 and 42 - these trees' trunks lie within or just outside the footprint of the proposed pool and associated retaining wall.

Tree #43 - portions of the proposed pool, synthetic turf area, and vegetated swale all lie within this tree's TPZ.

Trees #41 and 42 must be removed for the pool to be constructed.

As shown, the proposed vegetated swale at the southeast property corner will likely cause major impacts to tree #43 and minor impacts to tree #44 and Parcel 2 tree #25. We feel

this feature can likely be modified to reduce impacts to tree #43 with relative ease, but to our knowledge, this has not yet been explored.

Image 8: Northern California black walnuts #41-43 (left to right)

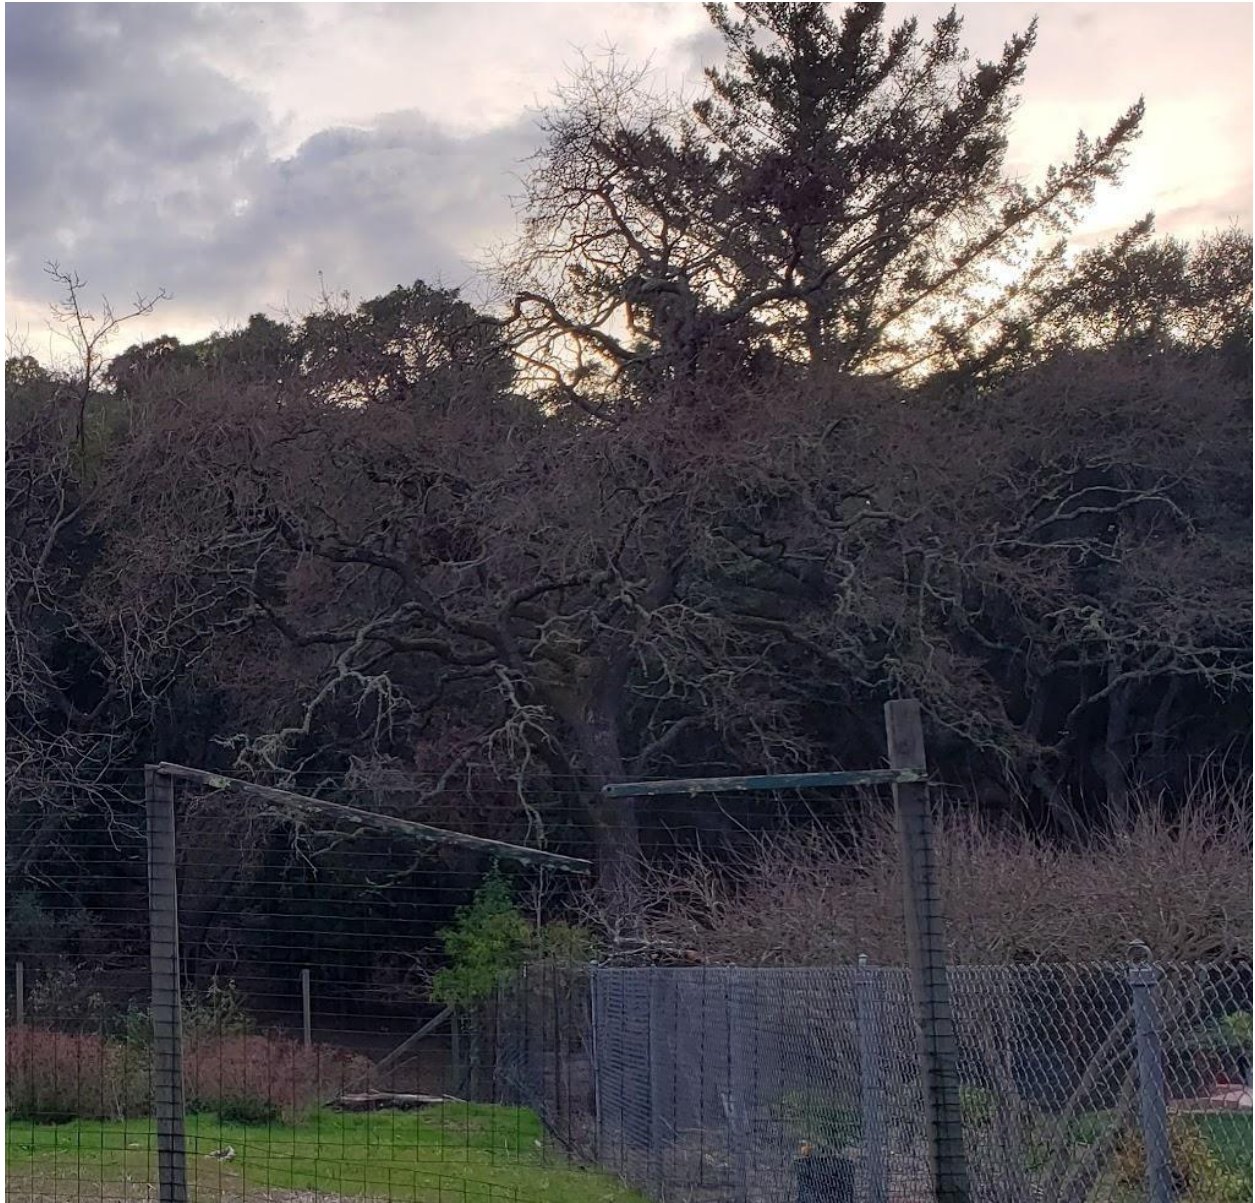
Tree #44 and Parcel 2 tree #25 - parts of the proposed vegetated swale lies within these trees' TPZs. A very small portion of the construction access route for the retaining wall for the pool patio area lies within the TPZ of Parcel 2 tree #25.

Image 9: valley oak #44

- 1. Provide supplemental irrigation for trees #2-4, 6, 8-10, 21, 22, 25, 29, 43, 44, and Parcel 2 tree #25
- 2. Plant replacements for trees #24, 30, 33, 35, and 37-42. Canopy sizes and replacement requirements are as follows:
 - a. Tree #24 - 20 feet - three 15-gallon trees
 - b. Tree #30 - 35 feet - four 15-gallon trees
 - c. Tree #33 - 30 feet - four 15-gallon trees
 - d. Tree #35 - 20 feet - three 15-gallon trees
 - e. Tree #37 - 20 feet - three 15-gallon trees
 - f. Tree #38 - 30 feet - four 15-gallon trees
 - g. Tree #39 - 15 feet - three 15-gallon trees
 - h. Tree #40 - 50 feet - six 24-inch box trees or three 36-inch box trees
 - i. Tree #41 - 20 feet - three 15-gallon trees
 - j. Tree #42 - 40 feet - four 15-gallon trees
